Fiber-Optics Sensing Applications

Characterizing aged bridge response by loading test

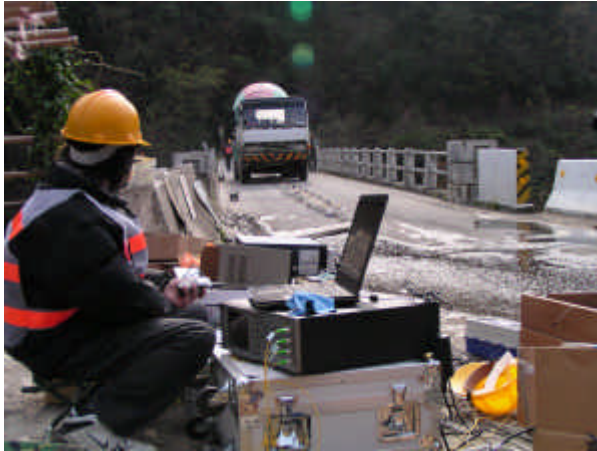
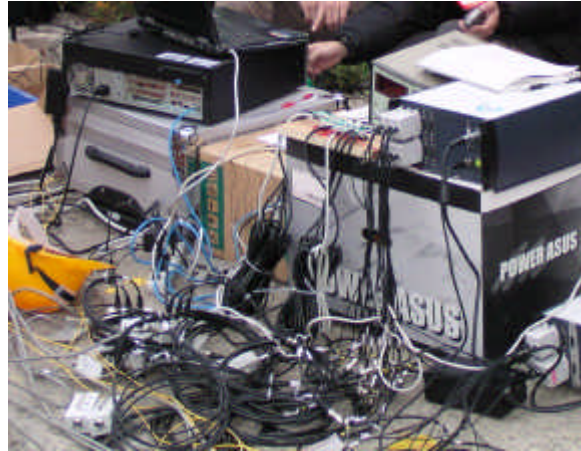
While in dynamic load testing, the same truck was driven across the bridge at 30km/hr speed and the FBG interrogator si425-500 recorded all the data at full speed of 250Hz. (see photo below)

In static loading test, a heavily loaded truck was parked at specified locations on the bridge for data recording.
